UNITED STATES
DEPARTMENT OF LABOR
MINE SAFETY AND HEALTH ADMINISTRATION

ACCIDENT INVESTIGATION REPORT
(UNDERGROUND COAL MINE)
NON-INJURY COAL OUTBURST
C-2, (I.D. NO. 15-07201)
HARLAN CUMBERLAND COAL COMPANY
DIONE, HARLAN COUNTY, KENTUCKY

JANUARY 11, 1990

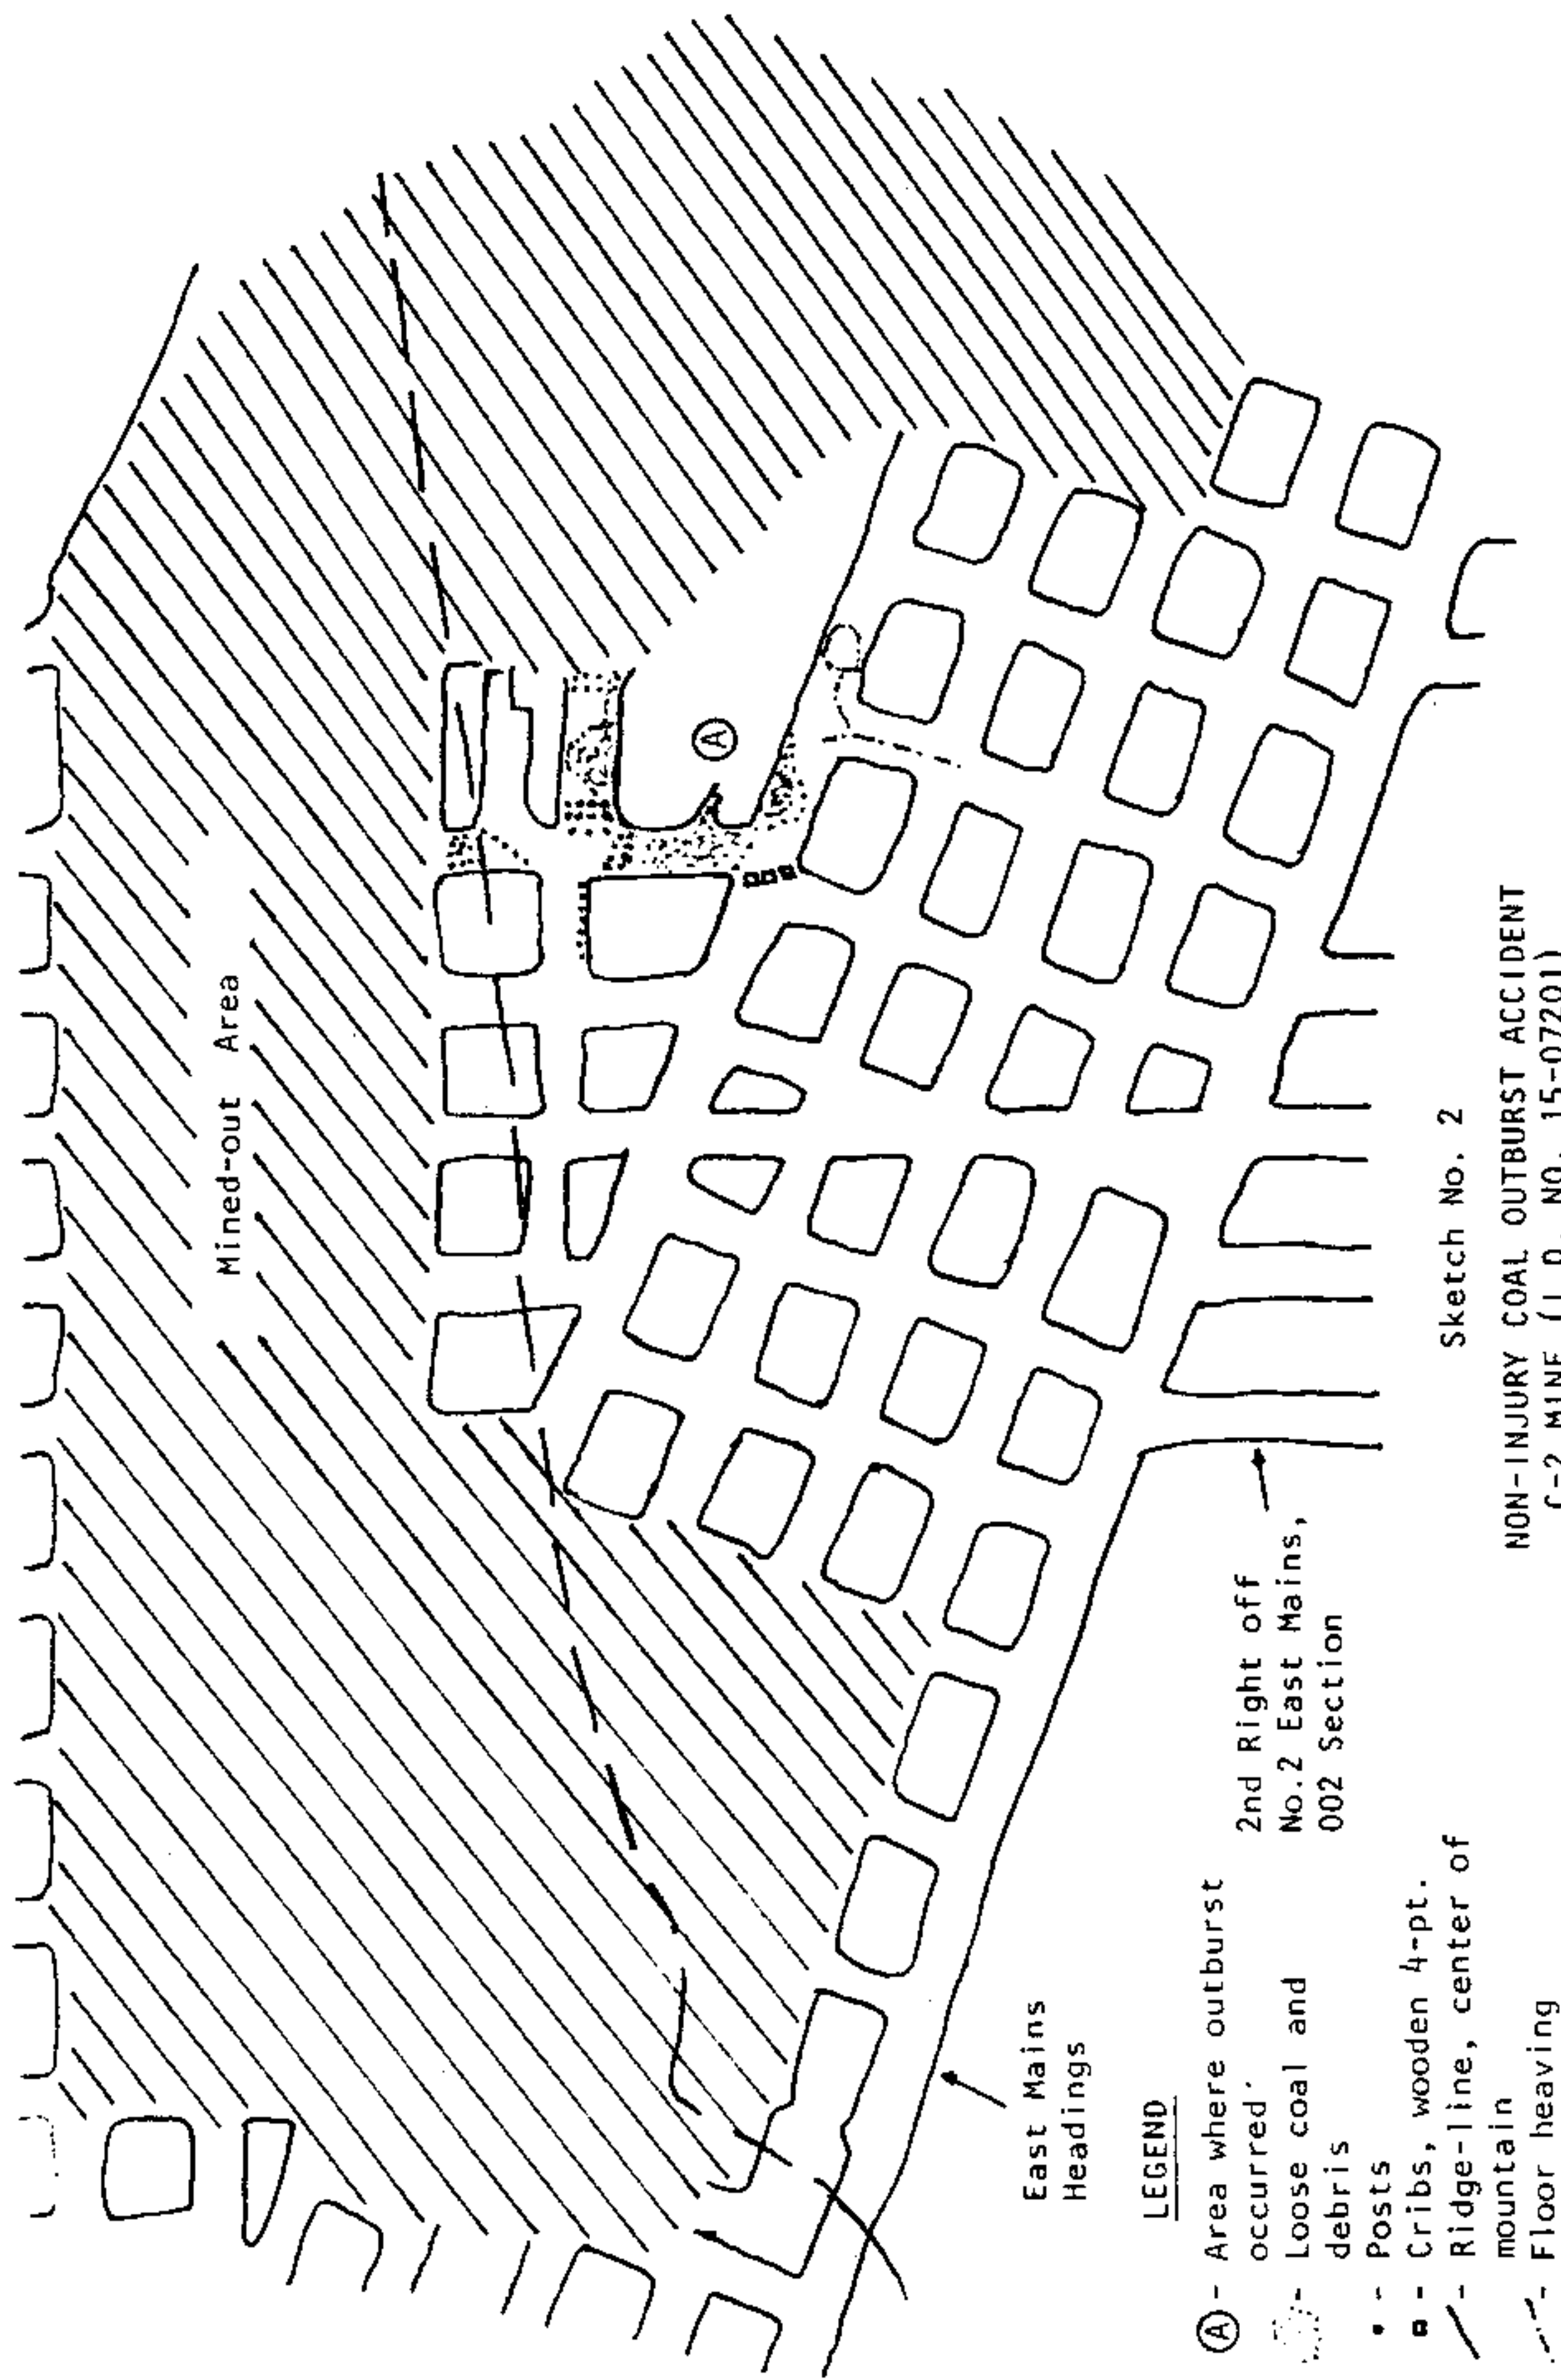
Sketch No. 2

The outburst caused extensive damage to the coal pillar developed between the No. 5 face entry and the old workings of the East Main headings, and moderate damage to the pillar adjacent to the left of the affected pillar. Large amounts of loose coal and debris were expelled from the inby crosscut rib and the No. 5 face entry rib of the affected pillar.

9. Approximately ninety-eight (98) tons of loose coal and debris were expelled from the affected pillars. The greatest amount of loose coal and debris was deposited between the two affected pillars in the No. 5 face entry. The material had been deposited to within eighteen (18) inches of the mine roof in this area.

10. The dimensions of the affected pillar, developed between the No. 5 face entry of the 002 section, and the old works off the East Main headings were approximately sixty (60) feet by fifty-five (55) feet by one-hundred seventy-five (175) feet. The side of the pillar adjacent to the old workings was inaccessible and its dimension could not be determined.

The apparently large cross-sectioned area of the affected pillar created an abutment zone of pressures exerted from the adjacent worked-out areas. The pressure induced by the mining of the cut-through in the inby pillar further increased the load on the affected pillar. This loading apparently increased to and beyond the load-bearing strength of the coal pillar, which resulted in its failure.

The damage sustained by the adjacent pillar could be attributed to the result of shock forces transmitted across the No. 5 face entry from the site of the outburst.
